Pasture/Hay Field

Introduction

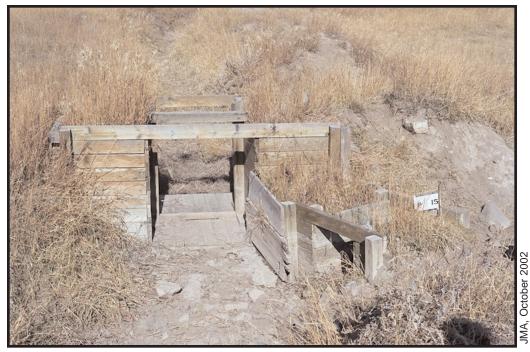
Other irrigation hardware includes a variety of different types of head gates, distribution gates, diversion dams, and culverts. **Head gates** are typically comprised of either two concrete or wooden head walls that are constructed on the inside edges of the main ditch (see Photo 3-5-6 and Photo 3-5-7). Closing these headgates (typically with wooden gates), allows water to be distributed into the smaller lateral/secondary ditches. In other instances, small wooden gates or metal **distribution gates** (consisting of a hand knob that controls the elevation of the gate) control this distribution (see Photo 3-5-8). Some of these distribution gates have headwalls, while others do not. Although not all headgates and distribution gates were inventoried during the field visit, most of those observed appeared to be in fair condition. A few wooden gates were in need of repair.

Photo 3-5-6: (K-24) Typical Wooden Headgate with Wooden Distribution Gate.

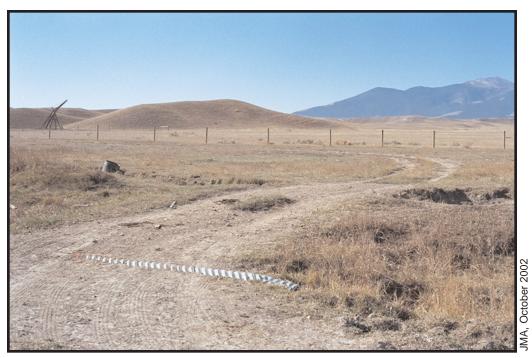
Within the Grant-Kohrs Ranch NHS, there are approximately 100 **culverts** that have been placed to contain these ditches. These culverts are generally placed underground to allow roads to pass over them, while others have been constructed to allow ditches to pass over or under other water bodies. There are many different types of culverts, including those constructed of metal, wood, PVC, and concrete (Photo 3-5-9). These culverts vary in length from three to over 20 feet.¹³

Photo 3-5-9: (L-19) Exposed Culvert.

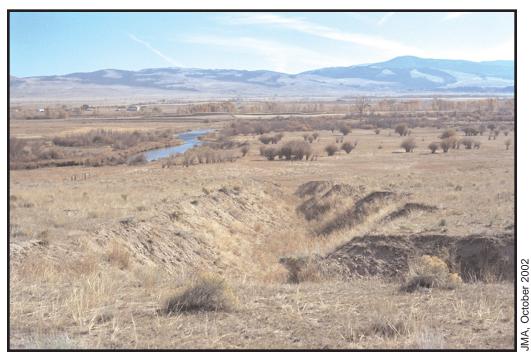
There are three primary north-south roads located within the pasture/hay field landscape areas. These include the **Kohrs Ditch Road** that generally follows the Kohrs "Big" Ditch on the west side of the ranch (see Photo 3-5-10). This road intersects with MTSR 4691 just outside of the park boundary. The road surface is dirt/gravel and approximately 10-12 feet wide. Just to the north of the Jensen hay-stacker, this road ends at a gate and continues on the western side of the park boundary fence. Just before the gate, a road branches off to the east and abruptly dead-ends where the unnamed gulch has eroded the road bed and made vehicular passage impassible (see Photo 3-5-11).

Photo 3-5-11: (K-04) Erosion at end of unnamed gulch on the west side of the ranch.

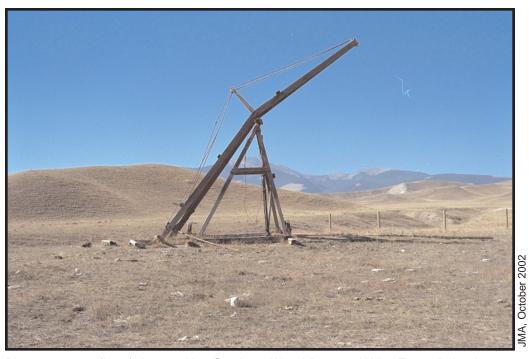
The **Jensen Hay-Stacker** (see Photo 3-5-14) is a wood frame structure measuring approximately 30 feet high. Its approximate 12 foot square base is constructed of four posts that are bolted into two braced timber leg supports that provide stability to the structure. Each of the four posts is joined together at a pivot point approximately 15 feet off the ground. Here a triangular beam is attached, supported by a pulley system. It is believed that this structure was loaded with loose hay at the base of the lever, which was then lifted to the top of the stack via the pulley system. The stacker was used with a net—the swing arm moved the net that was then tripped, and dumped hay on the pile. This structure was left in place ca. 1940. It is in a bad state of disrepair, with conservation and relocation to Stuart Field planned for 2004.

Photo 3-5-14: (L-24) Jensen Hay Stacker. Wood Post and Wire Fence in background.

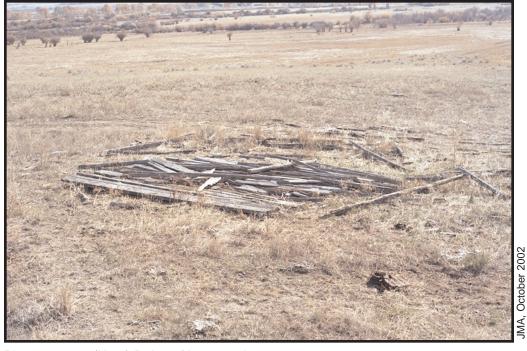
The **ruins** of a wood frame structure are located in the Western Hay Fields. (see Photo 3-5-18). These ruins are remnants of old hay panels, which were placed around stacks of hay to keep livestock out. It appears as those this structure collapsed many years ago and has been deteriorating for some time.

Photo 3-5-18: (K-19) Ruins of hay panels.
